TECHNICAL BULLETIN

No 00014_A, Release Date 1/17/2025

Creeping Pressure on Primary Regulators – CAR202407-01

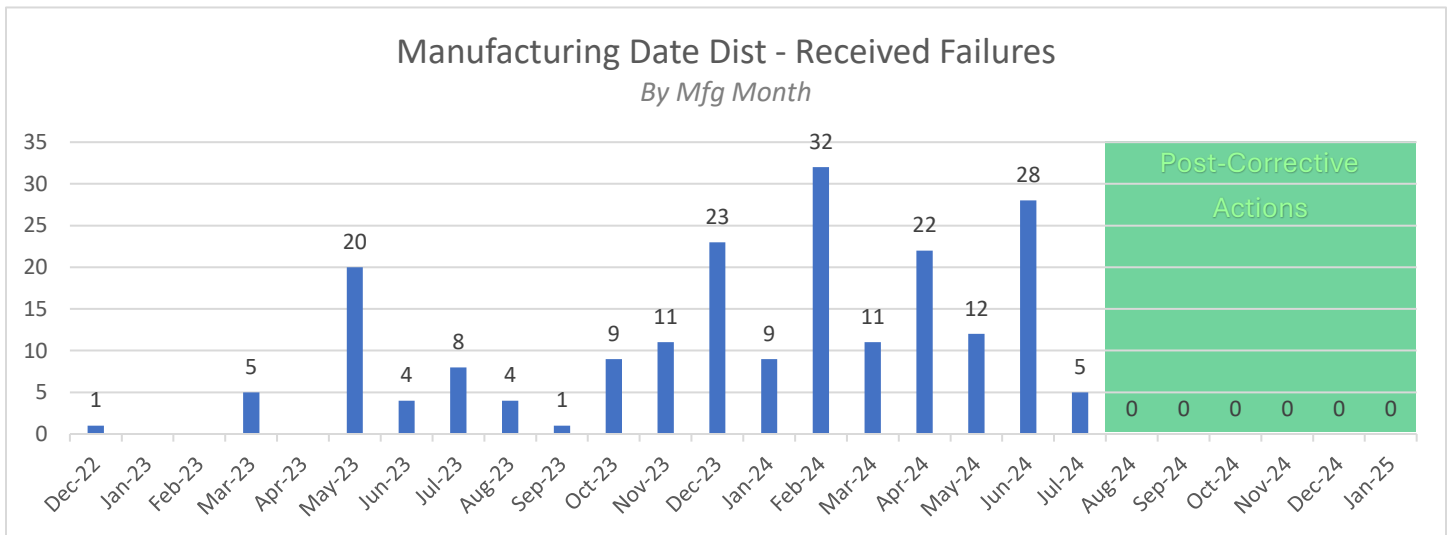
Field complaints have been received relating to creeping pressure in certain models of primary regulators. Beginning in March of 2024 and recurring in June and July with an upward trend in the 3rd and 4th quarter. The problem has been identified as relaxation of the compression force on the Teflon seat in the regulator’s Capsule. Internal testing is yet to determine if there is actual movement of the thread, or if the behavior is isolated to the flow properties of the seat under tension.

The graph below shows the build dates in which this defect has been confirmed. The total volume of failures received represents a .06% failure rate of the parts sold in those same months.

The problem was related to a new process implemented in 2023 which introduced variability to the fastening torque applied to the Capsule. This process change has been reversed, and new heavier duty and higher precision drivers were implemented in July of this year. As part of the containment measures, a secondary manual torquing process was implemented in July and remains in effect until more reliability data is available.

Regulators inside the 12-month warranty period which are experiencing creep, as defined in Taprite’s work instruction EWI-0101 when tested with a C02 bottle, should be returned to Taprite for replacement.

Alternatively, these can be field serviced by removing the capsule, clearing shavings and other debris from the capsule area and Teflon seat, and then retorquing the capsule to 40 inlbs.
